North American Performance Validation

For
AESTHETICS
and
DURABILITY
the choice for buildings is
PREPAINTED
55% Al-Zn
COATED STEEL

55% Al-Zn
THE MAGIC FORMULA
FOR METAL BUILDINGS

This report covers surveys of established metal buildings utilizing both prepainted 55% Al-Zn coated, and prepainted hot-dip galvanized, steels in the most aggressive acid rain zones of North America.

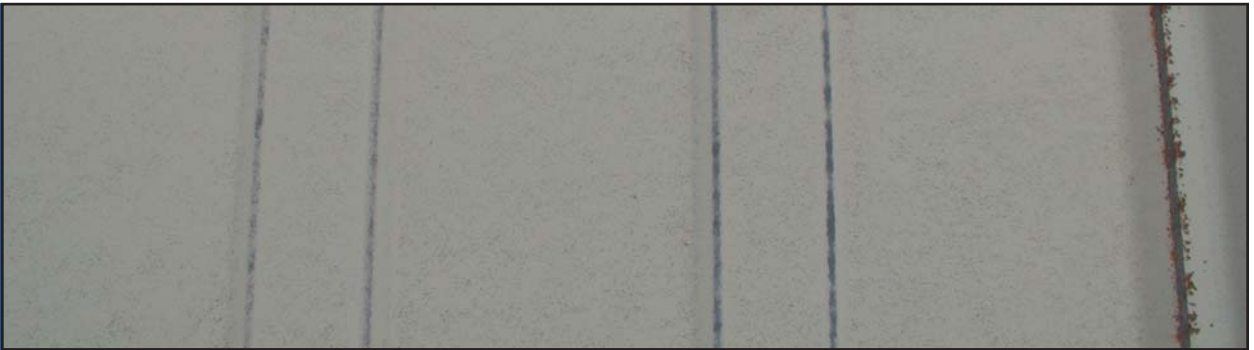
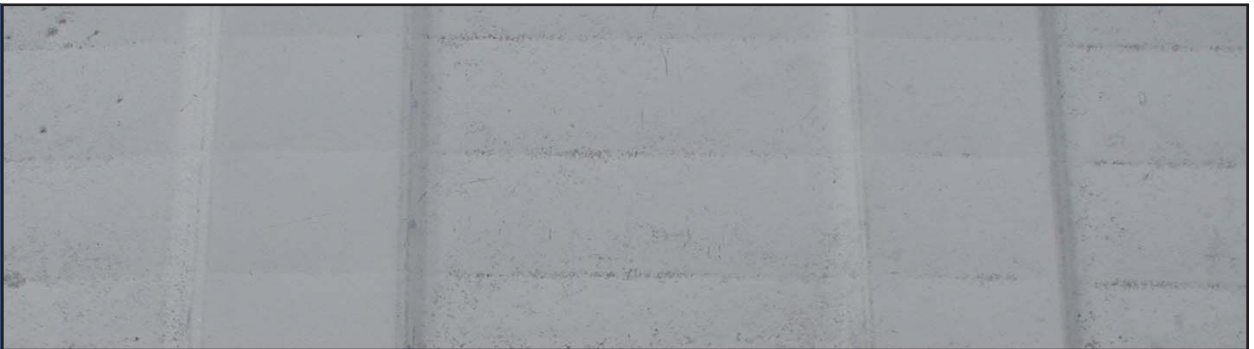
**PREPAINTED
HOT-DIP GALVANIZED**

**PREPAINTED
55% AL-ZN COATING**

**Corrosion performance at buildings in rural/acid rain Ontario:
hot-dip galvanized after 21 years; 55%Al-Zn coating after 17.5 years.**

**To resist corrosion initiated at panel bends and damage sites,
55% Al-Zn coated steel is a better choice of substrate for prepainting**

Long-term evaluations confirm that 55% Al-Zn coated steels outperform hot-dip galvanized at panel bends. At the more heavily-strained minor ribs, the performance differences are even more evident with the hot-dip galvanized performance deteriorating more than twice as fast as 55% Al-Zn coatings after 15 to 20 years exposure.

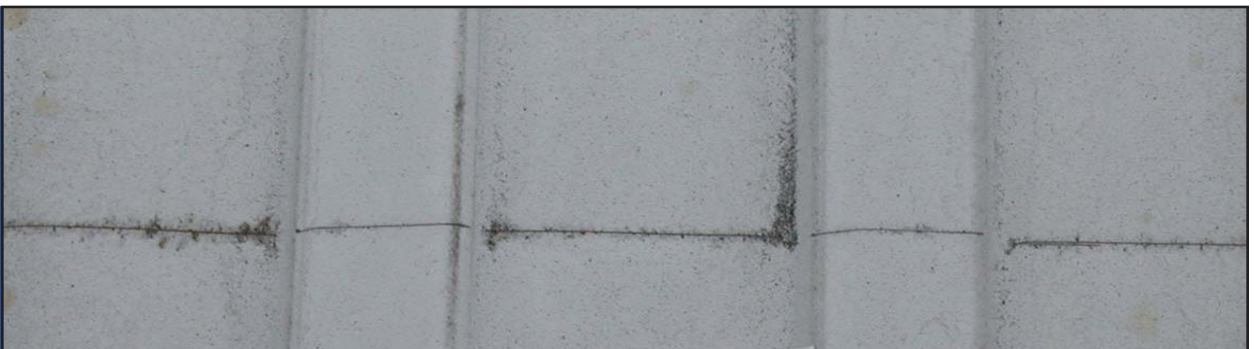
**PREPAINTED
HOT-DIP GALVANIZED**

**PREPAINTED
55% AL-ZN COATING**

**Corrosion performance at a manufactured defect (scribe) on buildings
in heavy industrial Ontario after 20 years exposure.**
